## KEMPEROL & COELAN

### The innovative solution for asbestos roof repairs

APPLICATION: ASBESTOS ROOF REPAIR

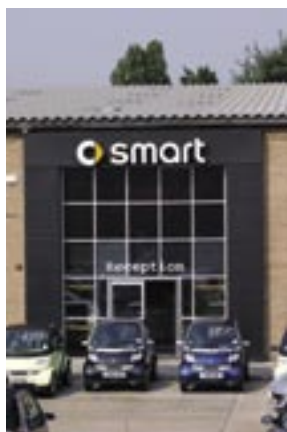
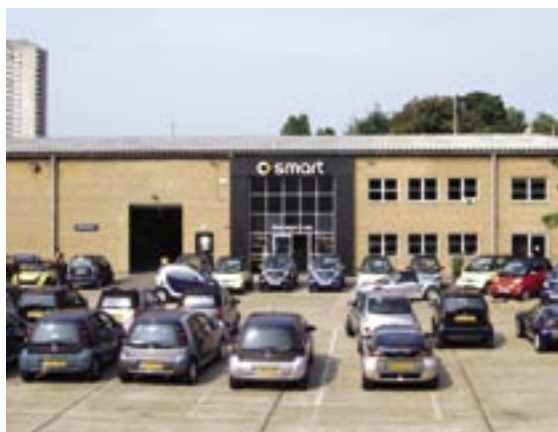
*Asbestos roof at busy London car dealership repaired and restored using Kemperol + Coelan.*
